SURVEY OF THE DILAPIDATED PORTIONS

HEREFORD CATHEDRAL,

IN THE YEAR 1841 :

THE REV. ROBERT WILLIS, M.A., F.R.S.,

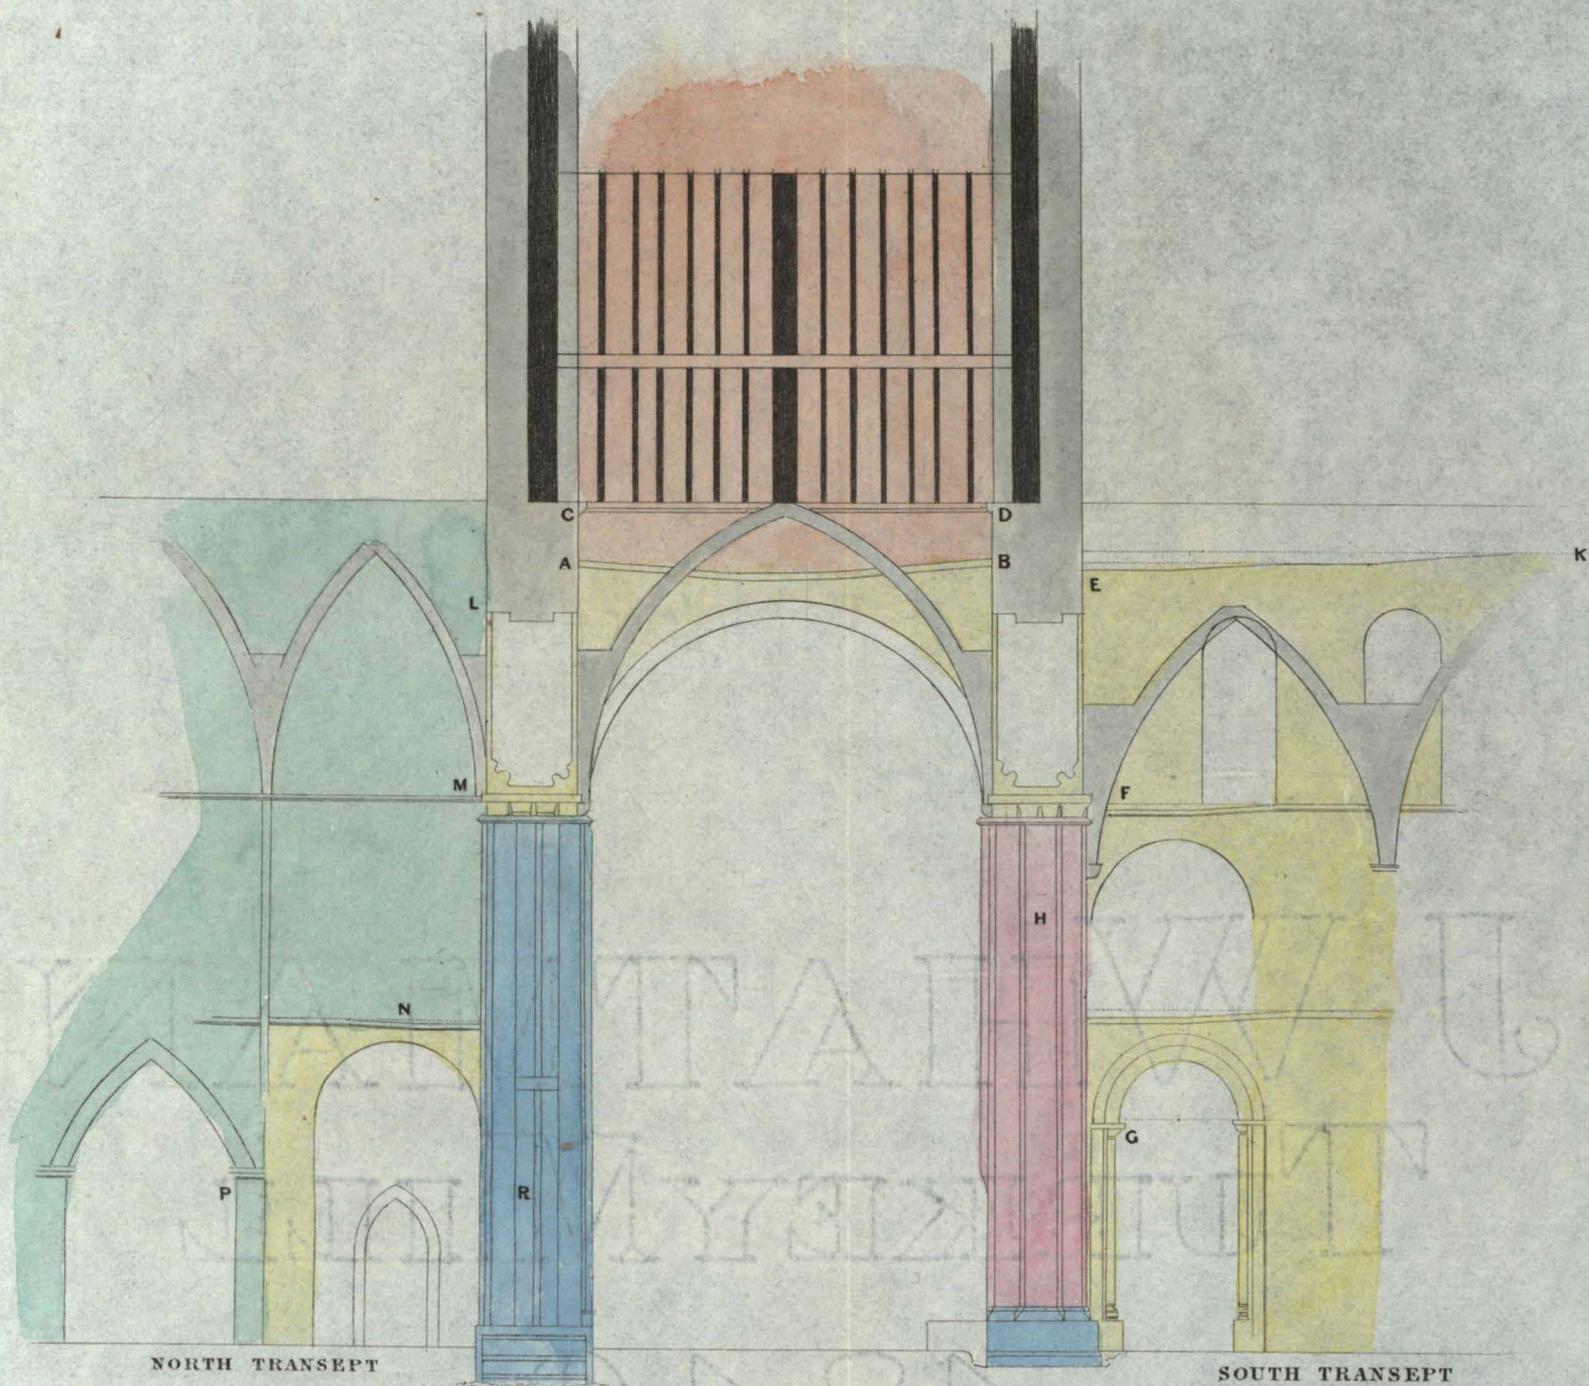
N^o 3. Section of the Tower from North to South looking East.

The masonry at E, the string course at F, and the impost at G, have all been carried down through the space of three inches and a half by the pier H, which is thus shewn to have sunk bodily into the foundation.

But at N is a local settlement occasioned by the sinking of the Norman arch immediately below it, which has also thrust out the pier at P to the north.

It would seem that the casing on the west face of the pier at R must have been subsequent to the bolstering of the opposite pier, for the plan (No. 1, z, z,) shews that its form is imitated from that produced by the latter at o, o.

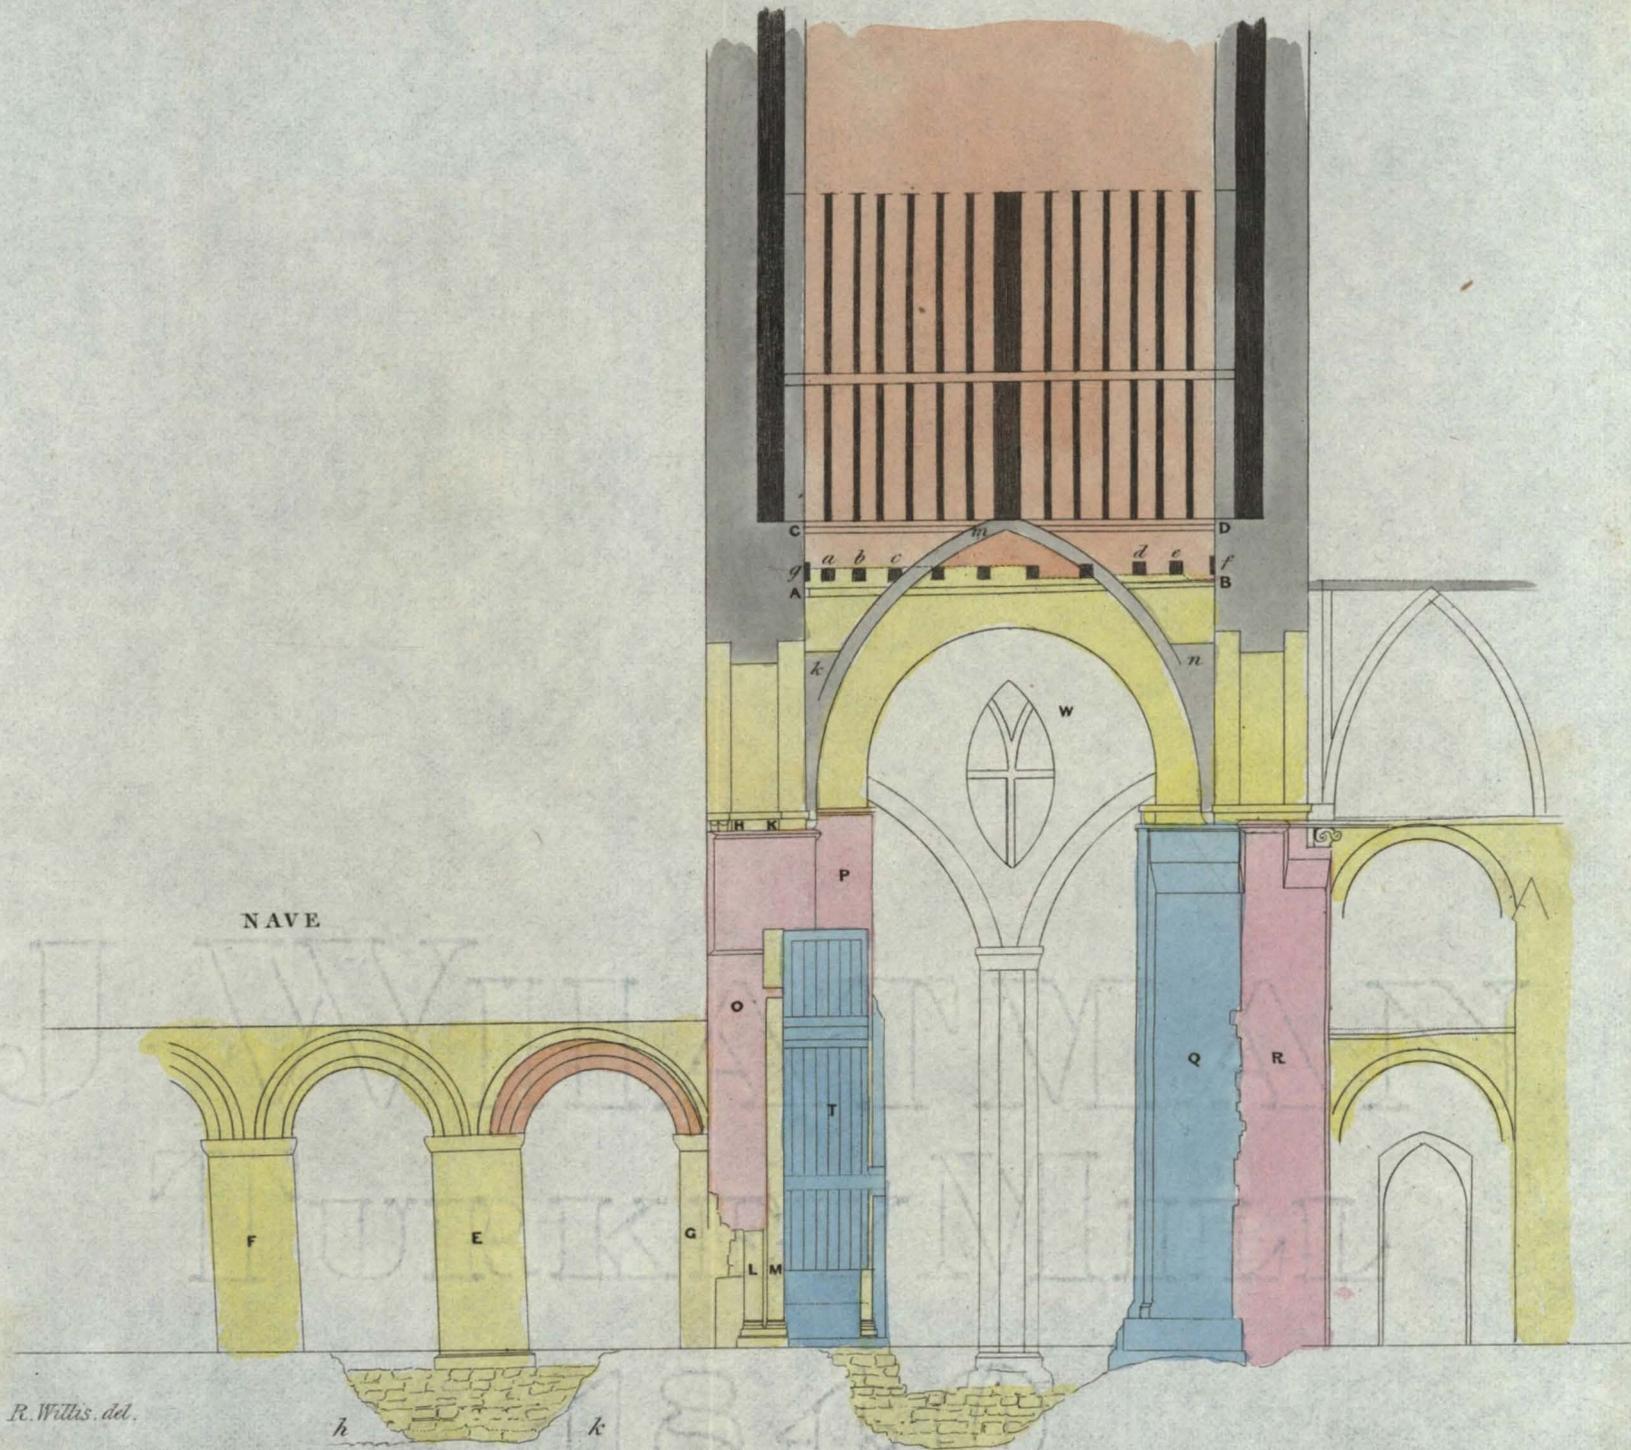
Nº 2. Section of the Tower from West to East looking North.

Section of the tower, with part of the nave and choir, from west to east.

A B, the Norman string course, seven inches lower at A than at B.

C D, the Gothic string course, very nearly level.

a, b, c, d, e, holes in which the beams of the Norman floor were inserted previously to the erection of the vault *k, m, n*. The dotted line is the boundary between the Norman and Gothic work.

f, g, the diagonal holes which extend into the heart of the wall.

The piers of the nave at E and F, are pushed out of the perpendicular, nearly five inches to the west, but G remains vertical; also the capitals at H and K, which were once vertically over their respective shafts L and M, are now ten inches and a half to the west of them, whence it may be inferred that the portion O, P, now repaired with newer masonry, together with the great arch above must have slipped away from the portions T, M, L, G, and thus thrust over the work of the nave. The ancient repairs upon the face of the pier, at Q and R, are shewn by the two tints, of which, the pink is the oldest, and probably immediately succeeded the completion of the tower.

h, k, is the level of the gravel; and the rough wall which rests upon it, and serves as a foundation for the piers, is shewn, as well as the manner in which the piers have been pushed bodily over.

T, the casing of long stones cramped against the Norman face. It must be recollected that the triforium and clerest-

W, the oxeye masonry.

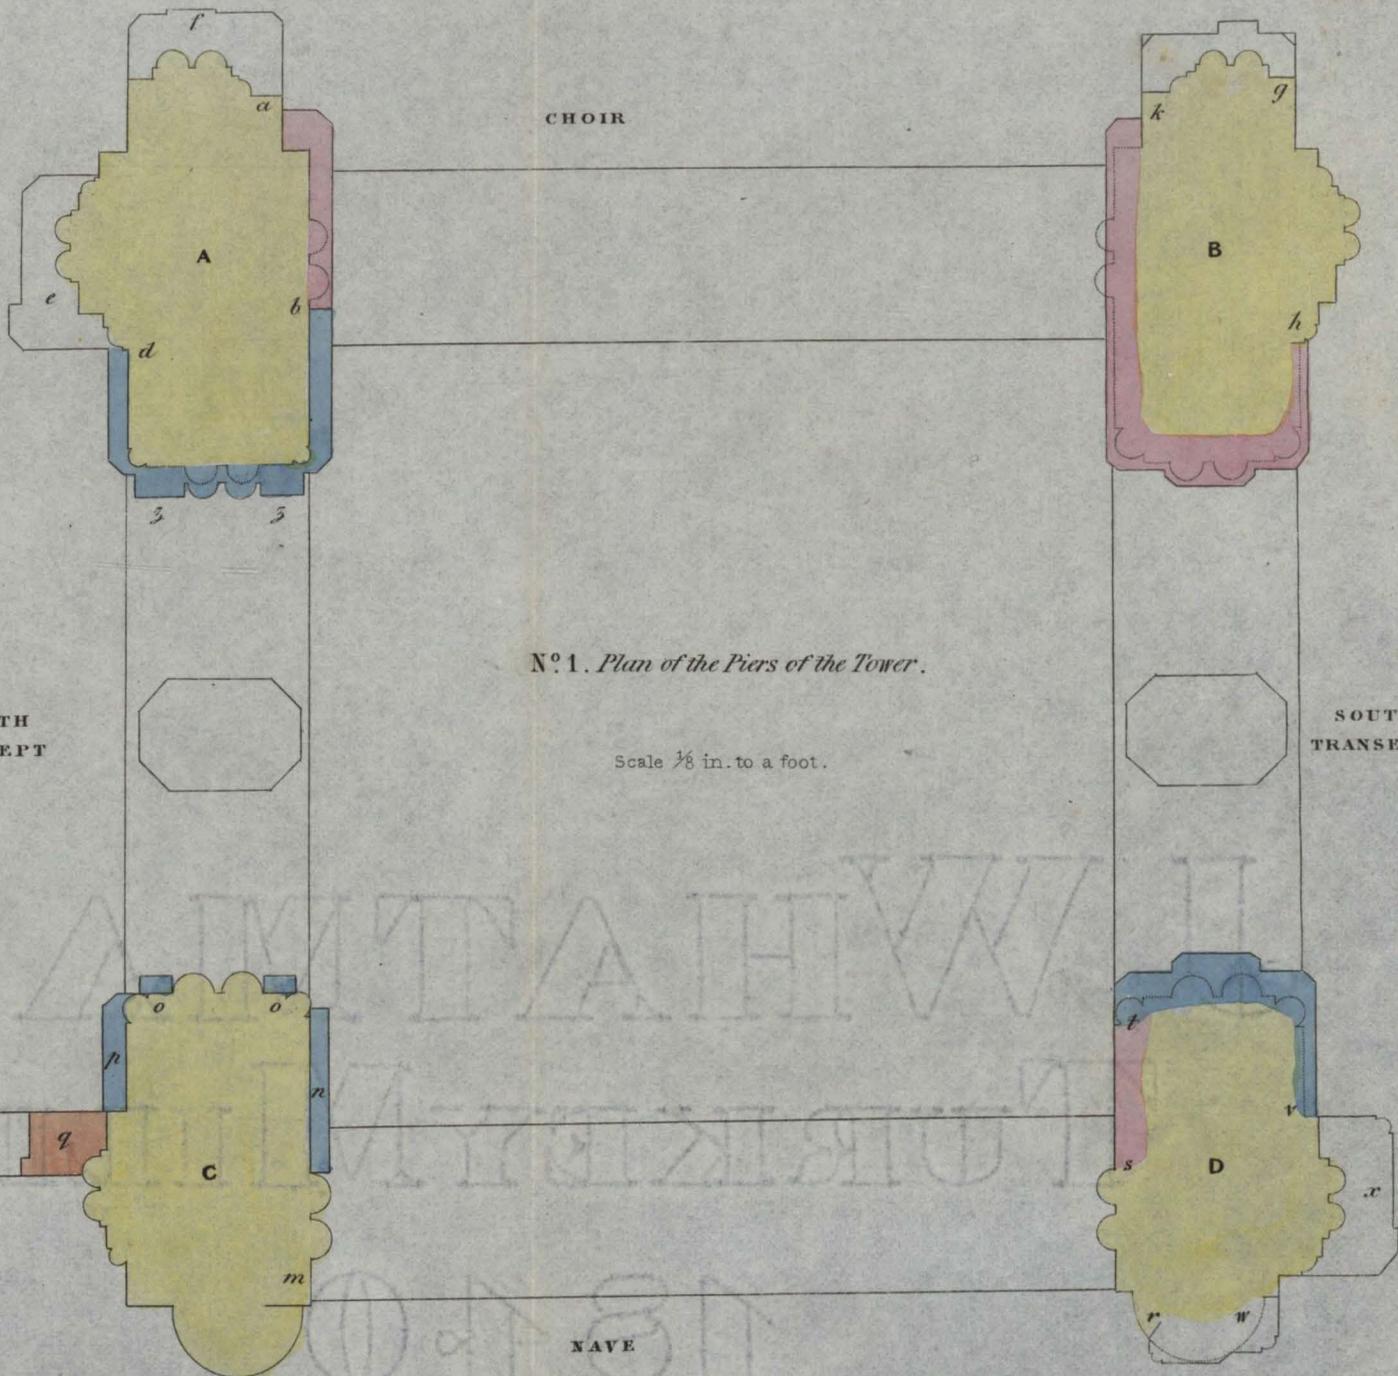
N^o 1. *Plan of the Piers of the Tower.*

Plan of the tower piers, to shew the alterations of form introduced by the successive casings and repairs.

The outline of the original Norman pier is shewn upon each.

The *north-east pier A*, has received an ancient casing from *a* to *b*, and a more recent one from *b* to *d*. It is uncertain whether these two casings are bonded into the Norman work, or whether they are merely cramped against its face. As they are of different dates, this fact should be ascertained for each. The arches which abut against the pier at *e* and at *f*, have been filled up, leaving doorways only, and this work is merely inserted, without disturbing the Norman face; this has been ascertained by withdrawing stones.

The south-east pier B still shews its Norman face, from *g* to *h*, and the same is undisturbed beneath the filling up of the arch from *k* to *g*. But from *h* to *k*, the outer surface of the pier has been substantially rebuilt.

The north-west pier C, retains its Norman face all round, with the exception of the ashling above *m*, which has been rebuilt, as is more clearly shewn by the elevation of this pier at O (No. 2). At *n*, *o*, and *p*, the pier has been bolstered up with long stones; and at *q*, the archway is filled up by masonry of the age of the tower.

The south-west pier D, retains its Norman face from *r* to *s*; from *s* to *t* the ashling is rebuilt, and from *t* to *v*, a second rebuilding appears, by which the face of the pier is brought forwards, and extended beyond the original Norman line. The north face of this pier therefore exhibits the two junctions of the three works at *s* and *t*; also at *w* the pier has been cut into and a more recent pier inserted, and at *x* the archway is filled up with masonry exactly similar to that at *e*.
